# Jordan Grand Condominium Owners Association

Newry, ME • April 28, 2022

FULL RESERVE STUDY

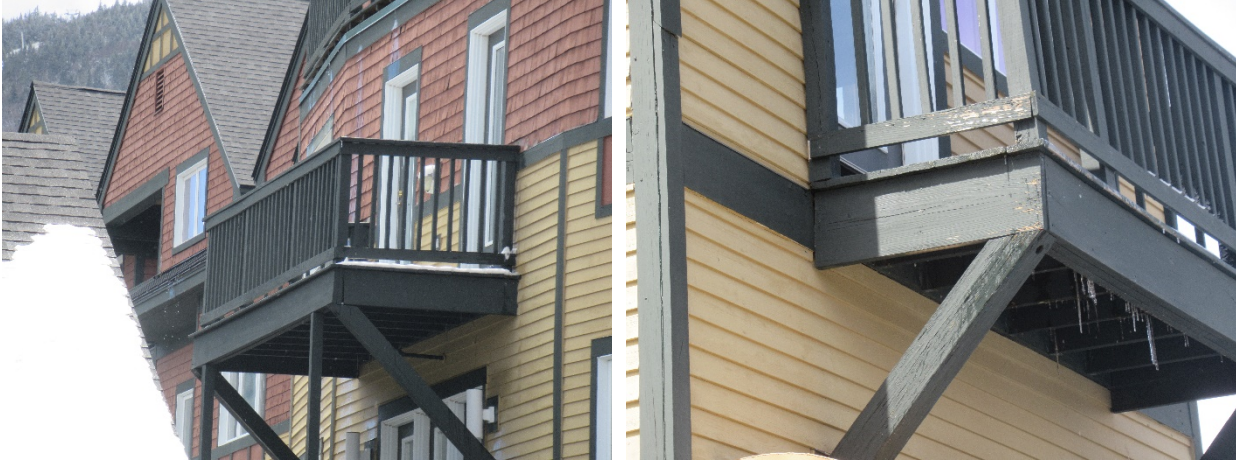
**Balcony**

**Wood and finish deterioration**

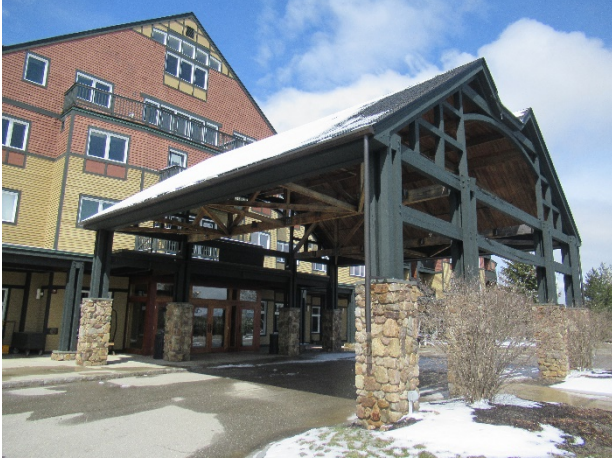
**Portico overview**

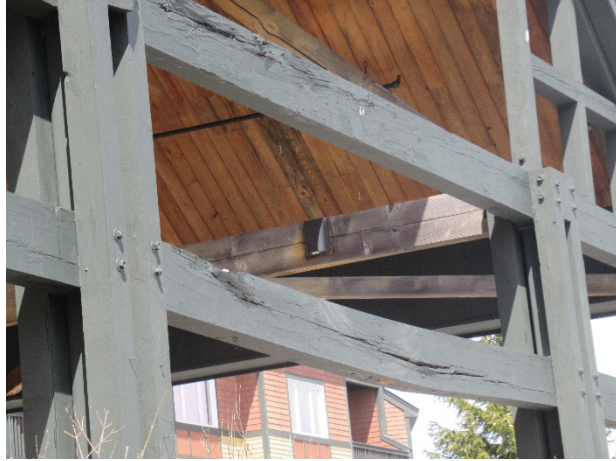
**Condition:** Poor overall with wood split and rot evident

**Wood split and rot and portico beams**

**Useful Life:** Indefinite with refinishing and repairs up to every 20 years.

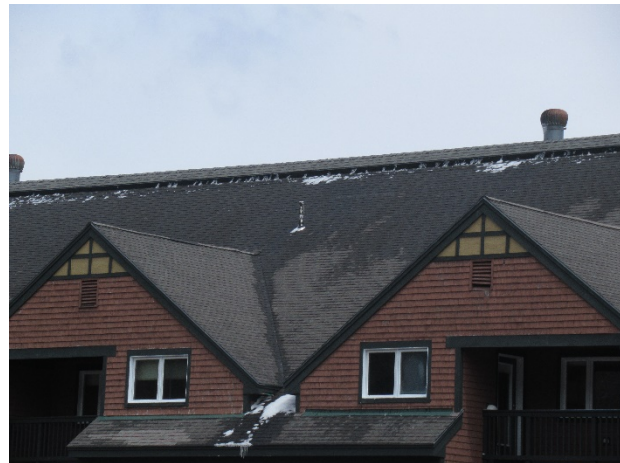
**Remaining original roof section**

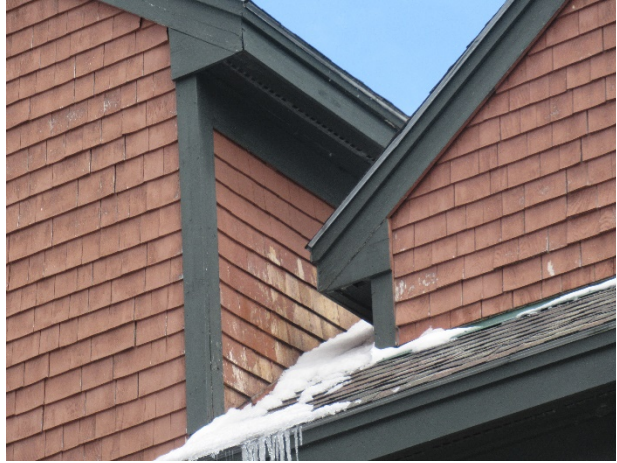
**Finish deterioration**

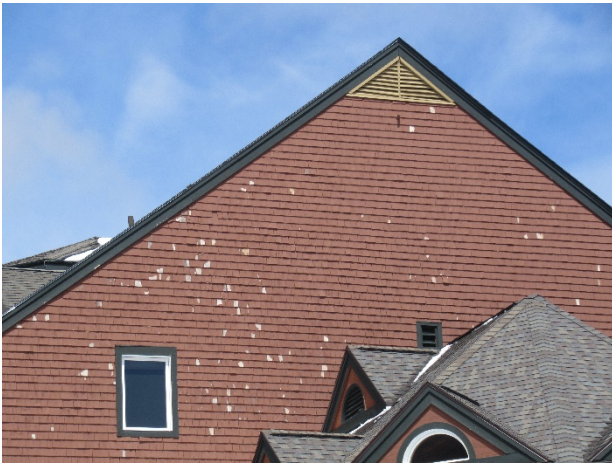
**Siding overview with finish deterioration and displaced shakes**

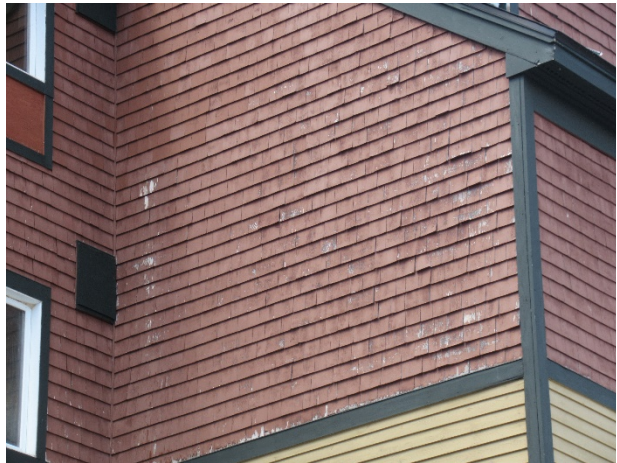
**Siding finish deterioration and warp**

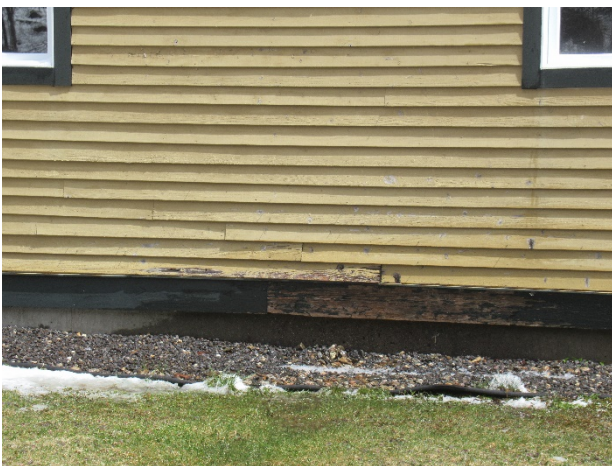
**Siding rot and finish deterioration**

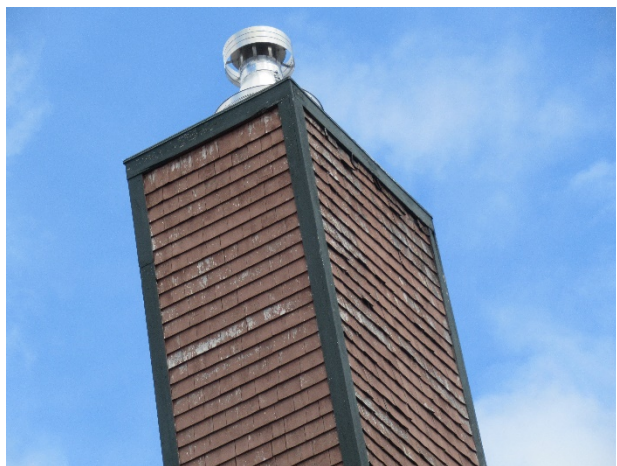
**Condition:** The siding is in fair overall condition and the paint finishes are in fair overall condition with finish and wood deterioration evident.

**Siding deterioration and finish deterioration at chimney chase**

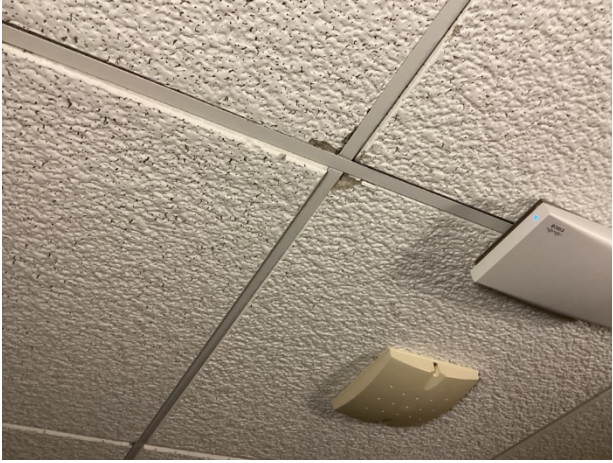
**Condition:** Fair overall with stains and deterioration evident

**Acoustical tile deterioration**

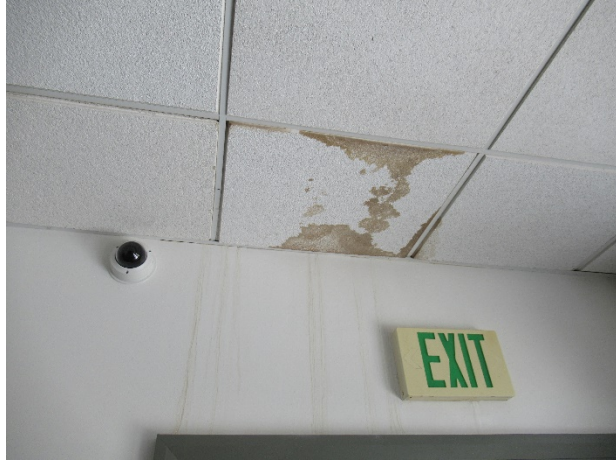
**Stains**

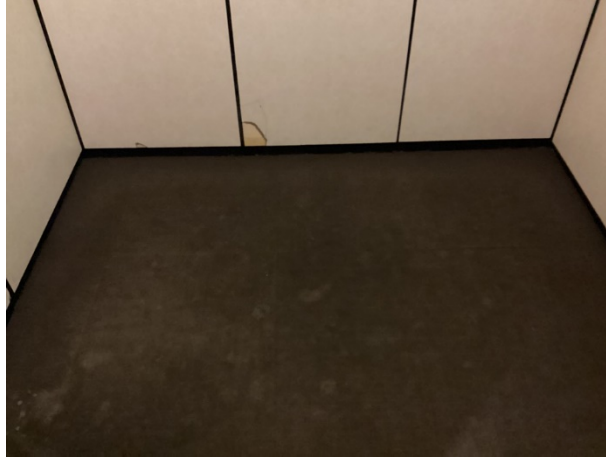
**Condition:** Fair to poor overall with deterioration and damage evident

**Elevator cab finishes**  
**Note: Carpet stains and wall damage.**

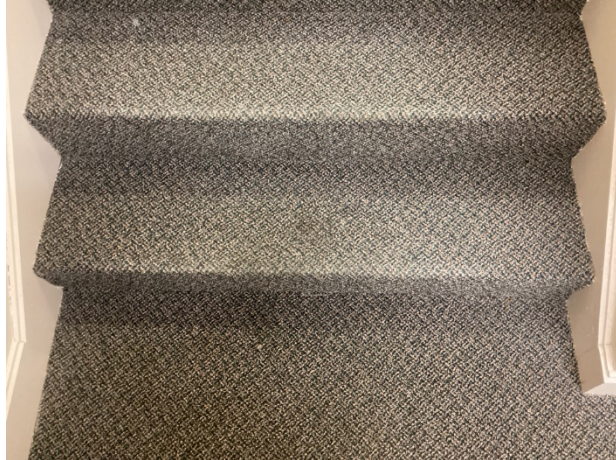
**Condition:** Fair to poor overall with general deterioration evident.

**Stairwell carpet deterioration**

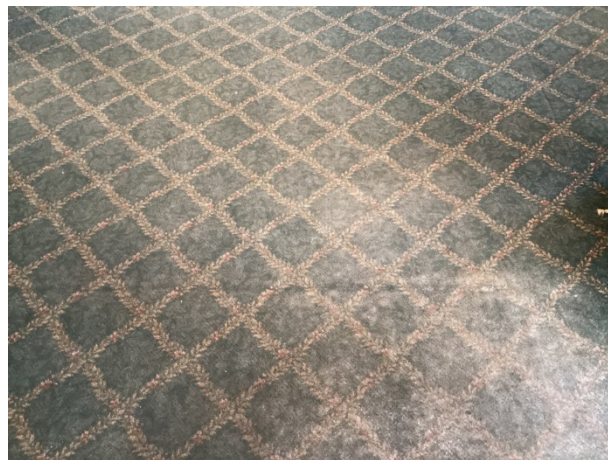
**Condition:** Fair overall with general deterioration evident

**Lobby carpet deterioration**

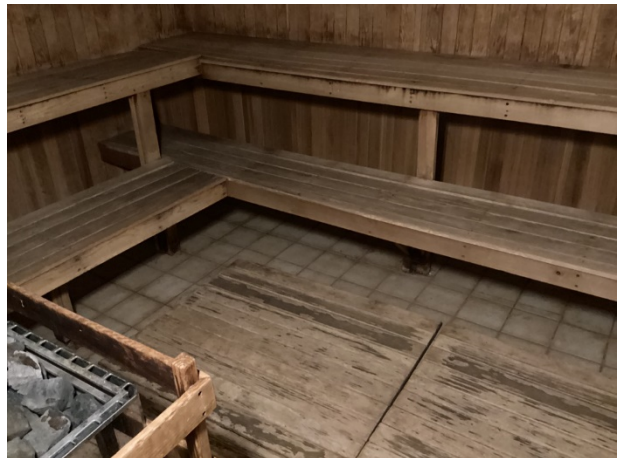
**Sauna finishes**  
**Note: General wood deterioration.**

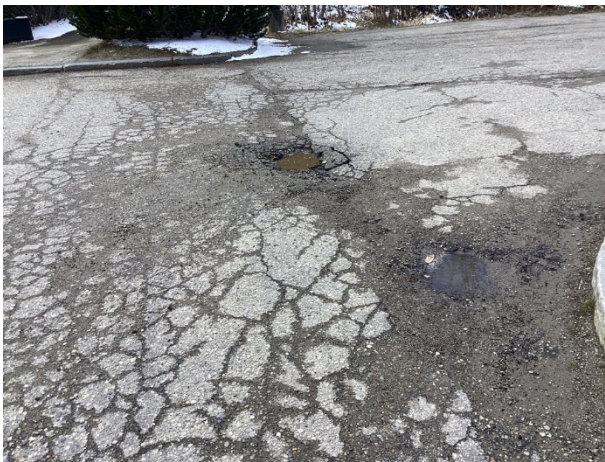
**Condition:** The entrance driveway and parking area is in good to fair overall condition. The upper parking area is in fair to poor overall condition with cracks, edge deterioration and alligator cracks evident.

**Alligator cracks at upper parking area**

The manner of repaving is either a mill and overlay or total replacement. A mill and overlay is a method of repaving where cracked, worn and failed pavement is mechanically removed or milled until sound pavement is found. A new layer of asphalt is overlaid atop the remaining base course of pavement. Total replacement includes the removal of all existing asphalt down to the base course of aggregate and native soil followed by the application of two or more new lifts of asphalt. We recommend mill and overlayment on asphalt pavement that exhibits normal deterioration and wear. We recommend total replacement of asphalt pavement that exhibits severe deterioration, inadequate drainage, pavement that has been overlaid multiple times in the past or where the configuration makes overlayment not possible. Based on the apparent visual condition and configuration of the asphalt pavement, we recommend the milling and overlayment method of repaving followed by the total replacement method of repaving for the entrance driveway and parking area at Jordan Grand Condominium Owners Association. We recommend the total replacement method of repaving followed by the milling and overlayment method of repaving for the upper parking area.

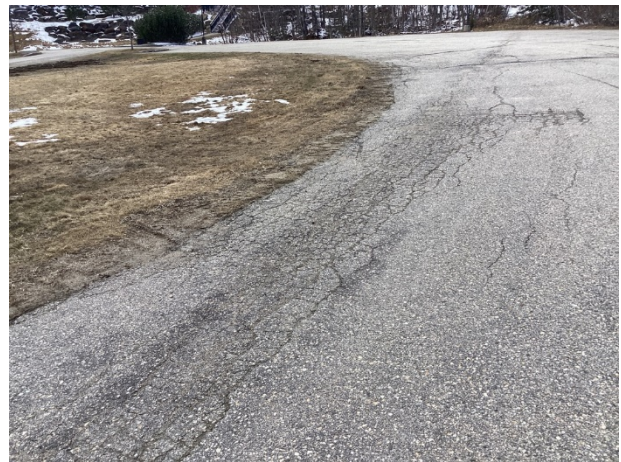
**Edge deterioration and alligator cracks at upper parking area**

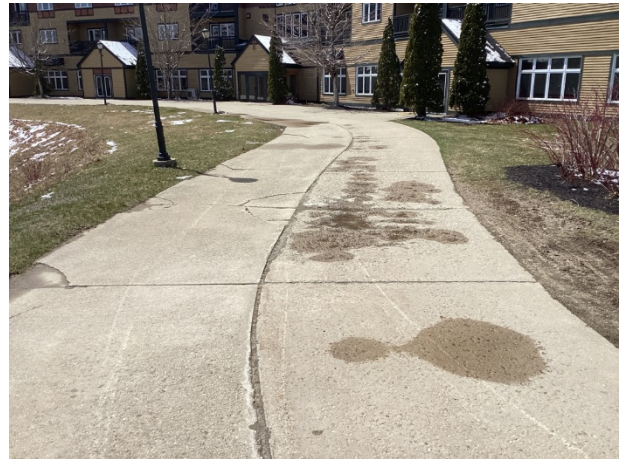
**Condition:** Fair overall with cracks and spalls evident

Sidewalk overview with cracks and spalls

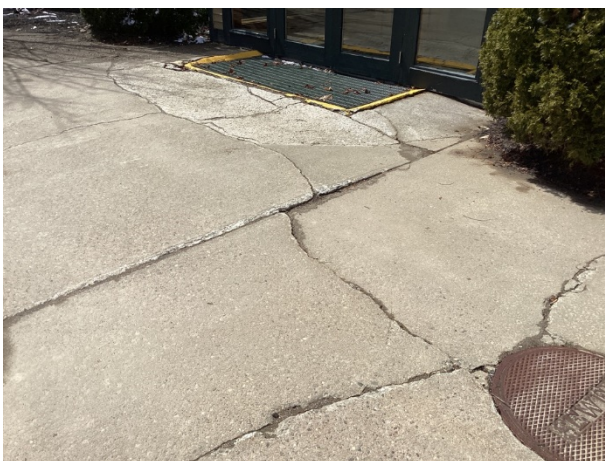
Sidewalk cracks

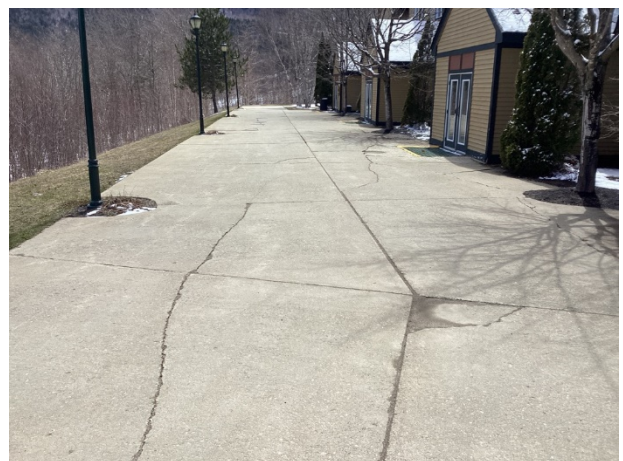
Sidewalk overview with cracks and settlement

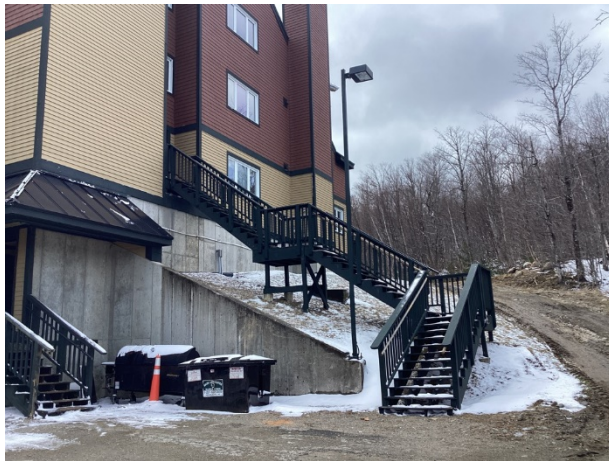
**Condition:** Fair overall with leaning posts evident

Light pole and fixture

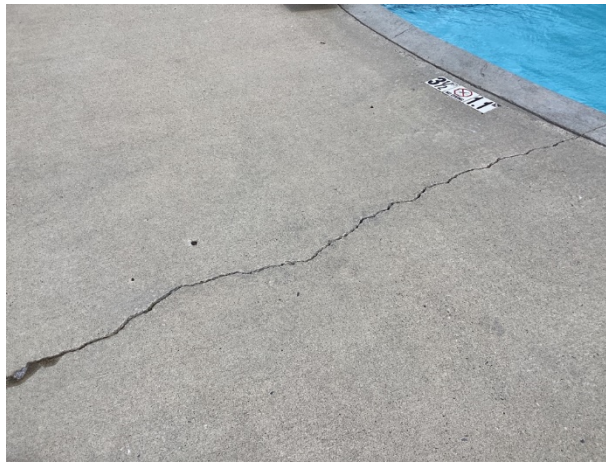
**Condition:** Good to fair overall with cracks evident

**Concrete cracks**
