# Jordan Grand Condominium Owners Association

Newry, ME • April 28, 2022

FULL RESERVE STUDY

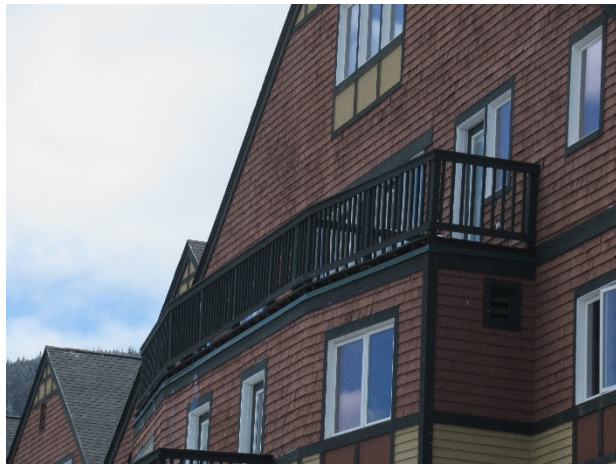
**Condition:** Reported satisfactory. Management inform us the balconies were professionally inspected in 2022 and are in satisfactory and sound condition.

Balconies

Balcony at flat roof

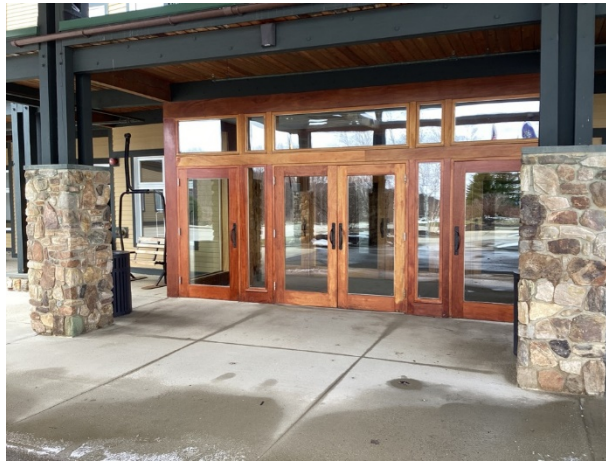
**Condition:** Reported satisfactory

**Main entrance doors**

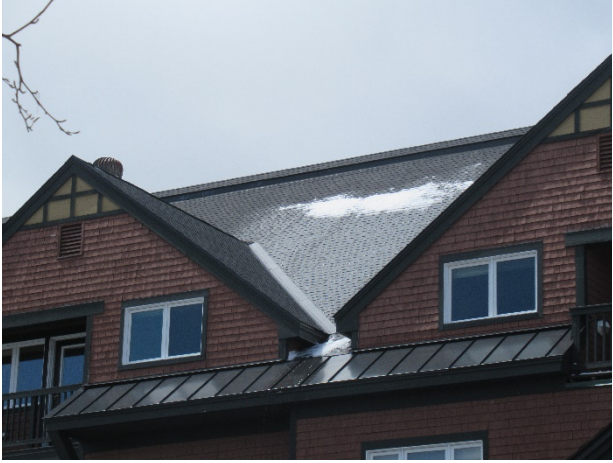
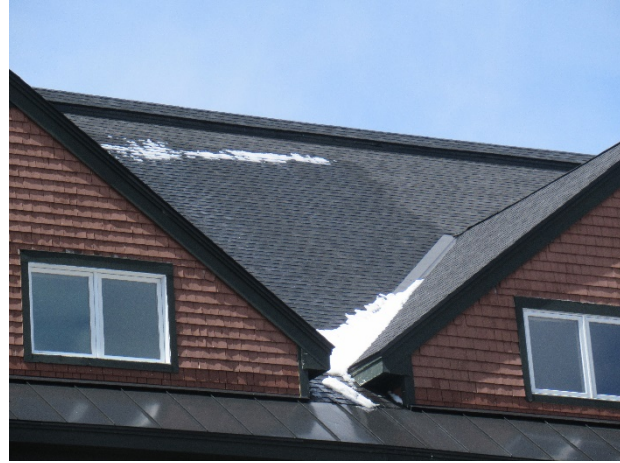
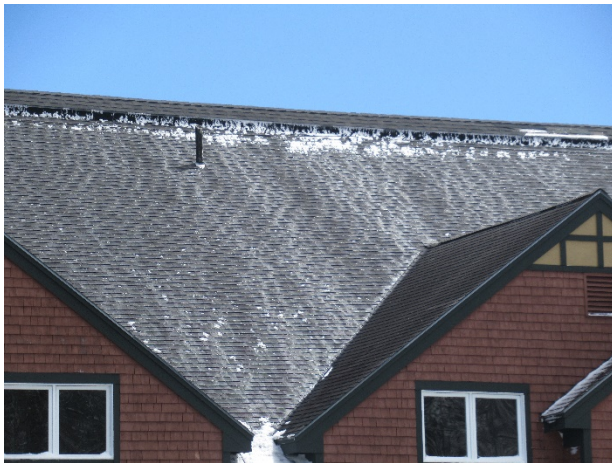
**Condition:** We assume the roofs will be in satisfactory condition upon completion of the ongoing roof replacement project.

**Replaced roof overview**

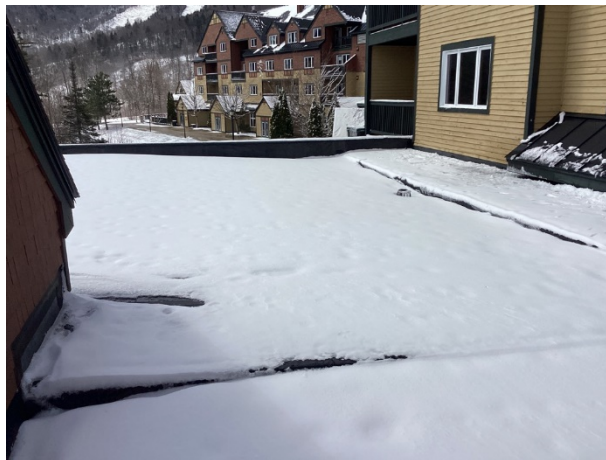
**Condition:** Reported satisfactory without leaks. We were unable to inspect the flat roofs due to snow cover.

Flat roof overview

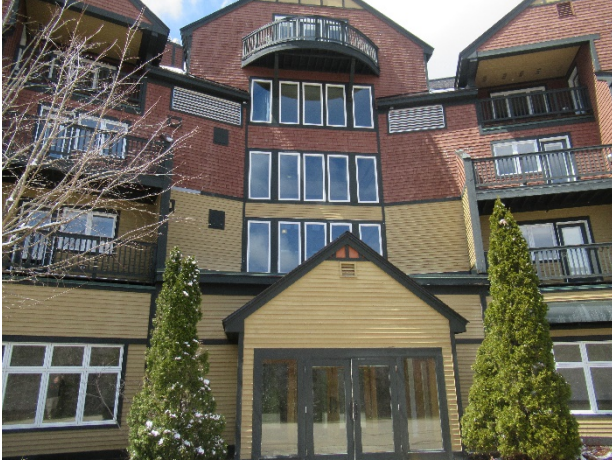
**Condition:** The siding is in fair overall condition and the paint finishes are in fair overall condition with finish and wood deterioration evident.

**Wood siding overview**

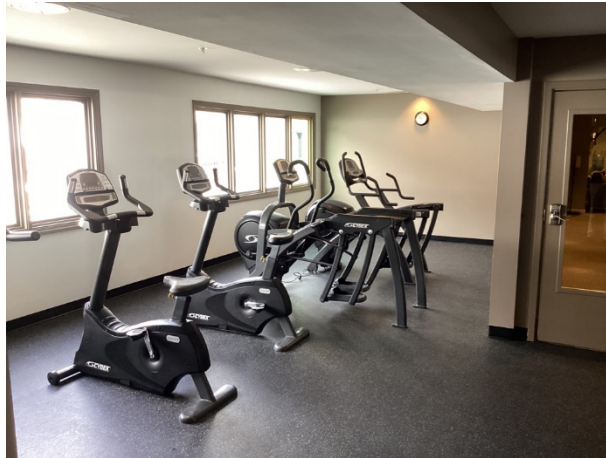
**Condition:** Good to fair overall with no significant deterioration evident.

**Exercise room finishes**

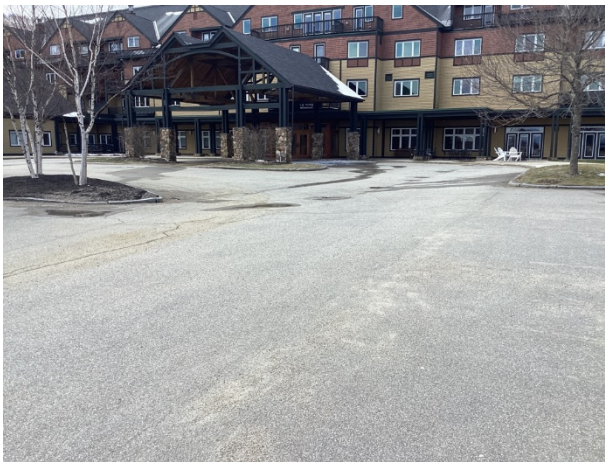
**Entrance driveway and parking area overview**

**Condition:** The entrance driveway and parking area is in good to fair overall condition. The upper parking area is in fair to poor overall condition with cracks, edge deterioration and alligator cracks evident.

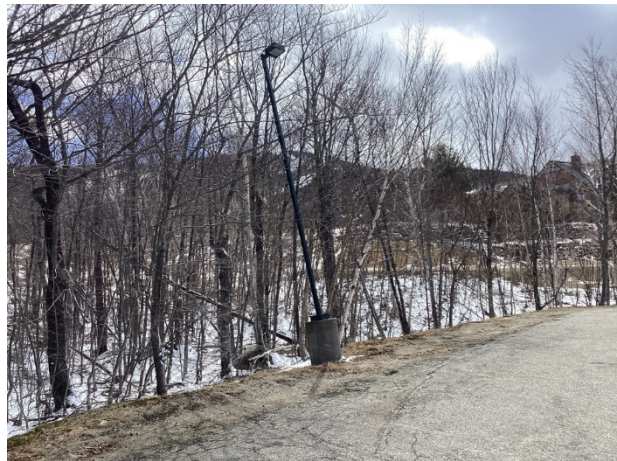
Leaning light pole and fixture

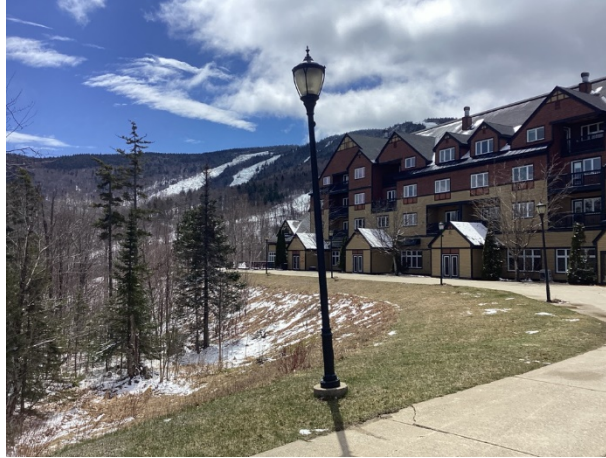
**Leaning light pole and fixture**

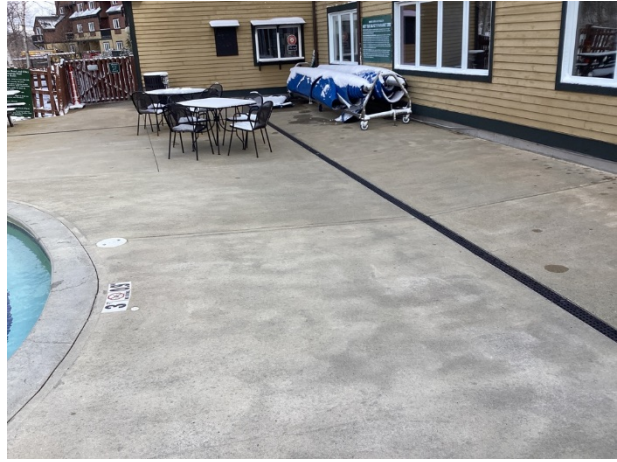
**Concrete pool deck overview**

**Condition:** Good to fair overall with cracks evident

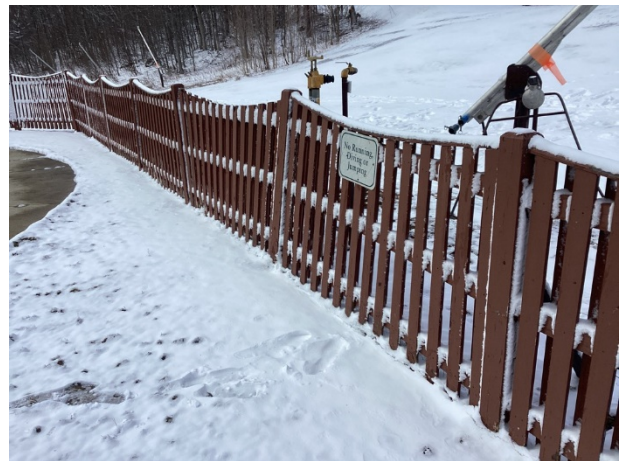
Fence leaning section

- Annually:
  - o Inspect and repair loose fasteners or sections, and damage
  - o Repair leaning sections and clear vegetation from fence areas which could cause damage

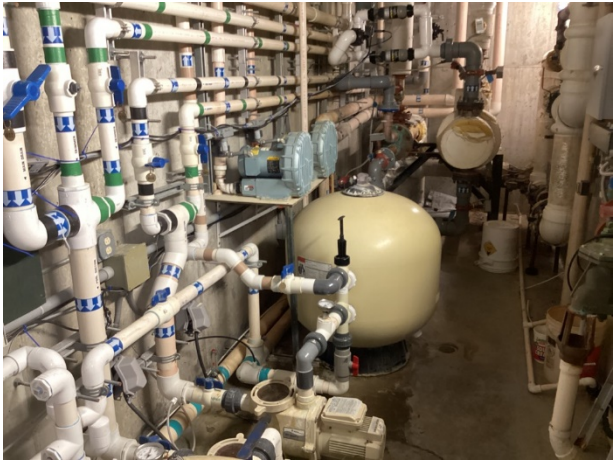
**Pool mechanical equipment**

**Condition:** Reported satisfactory without operational deficiencies
