# Jordan Grand Condominium Owners Association

Newry, ME • April 28, 2022

FULL RESERVE STUDY

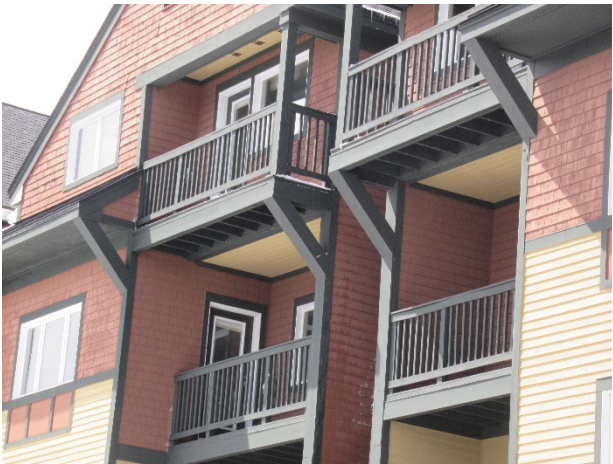
**Condition:** Reported satisfactory. Management inform us the balconies were professionally inspected in 2022 and are in satisfactory and sound condition.

Balconies

Balcony at flat roof

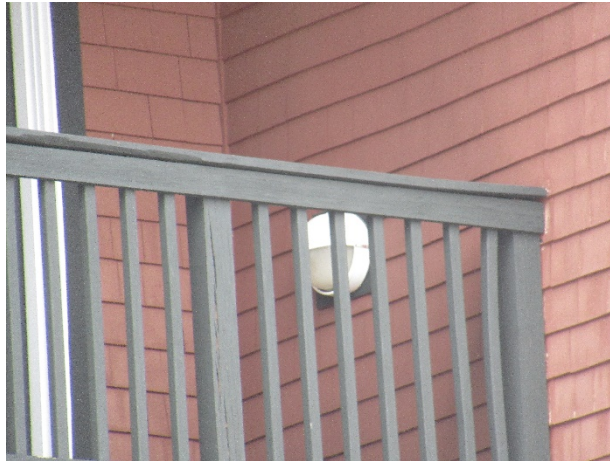
**Condition:** Reported satisfactory

**Balcony light fixture**

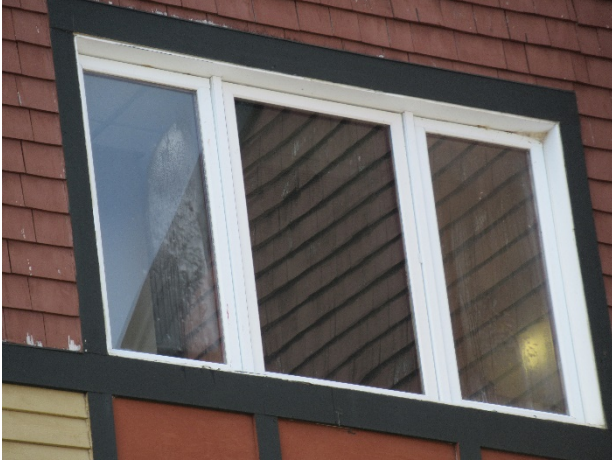
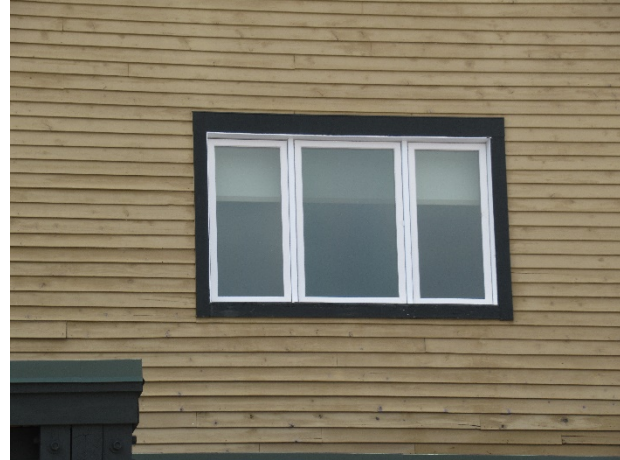
**Condition:** Reported generally satisfactory with a limited history of operational deficiencies.

**Windows**

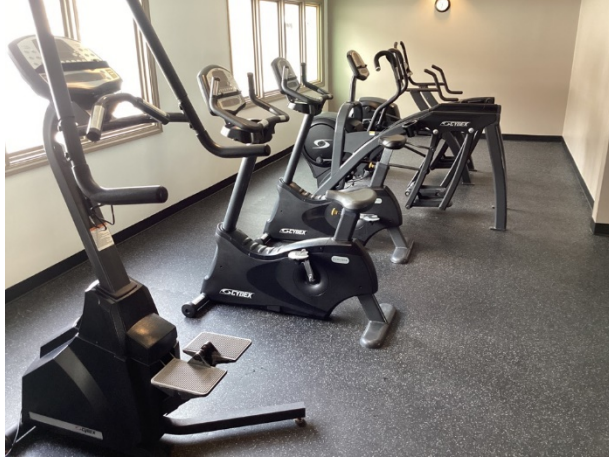
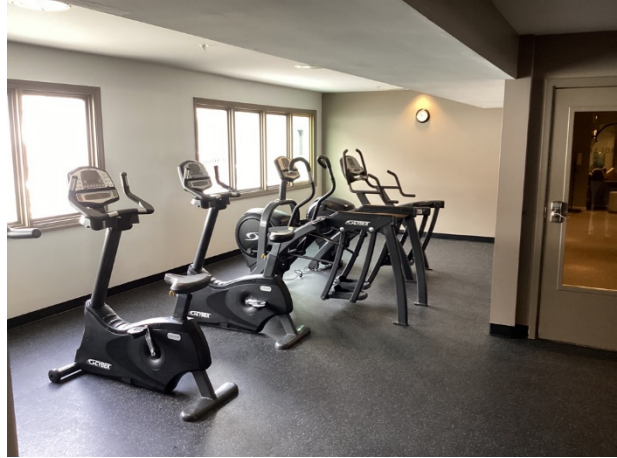
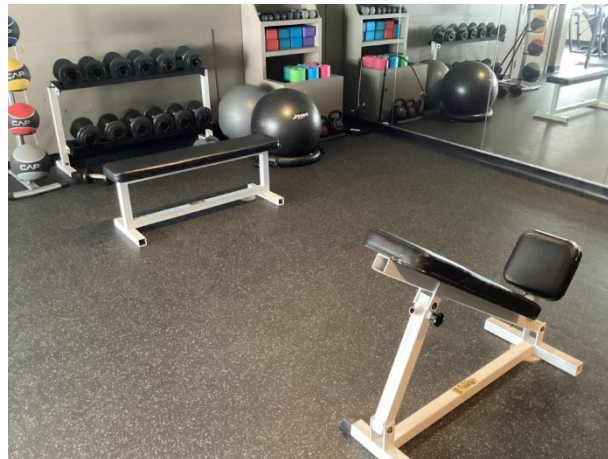
**Conditions:** Reported unsatisfactory

**Cardiovascular exercise equipment**

**Exercise room**

**Strength training exercise equipment**

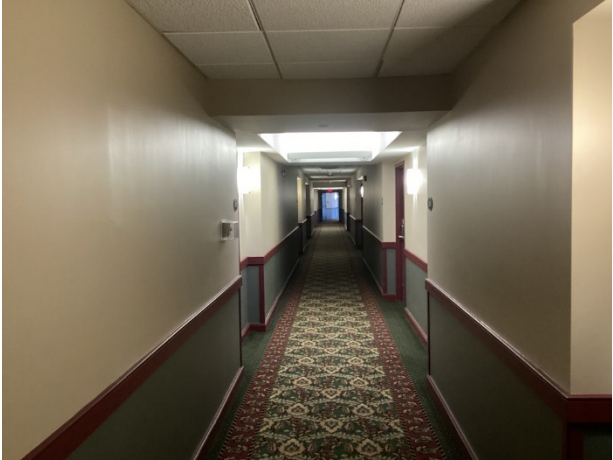
**Condition:** Fair to poor overall with general deterioration evident.

**Hallway overview**

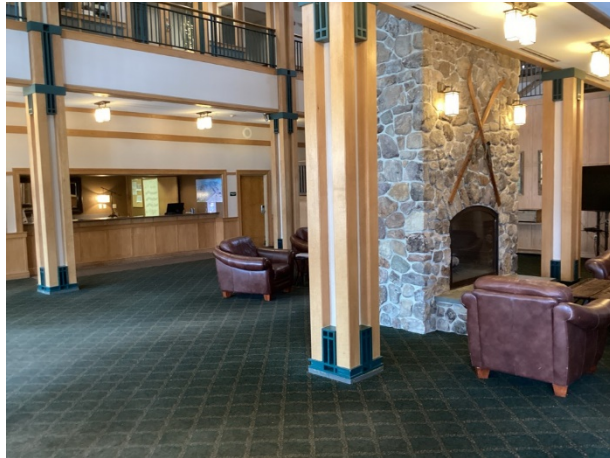
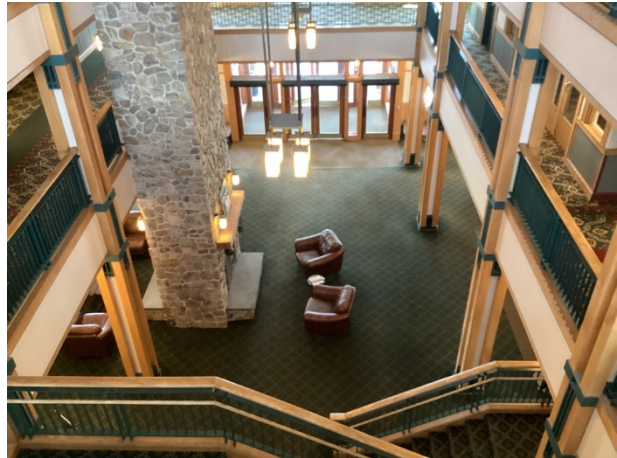
**Condition:** Fair overall with general deterioration evident

**Lobby**

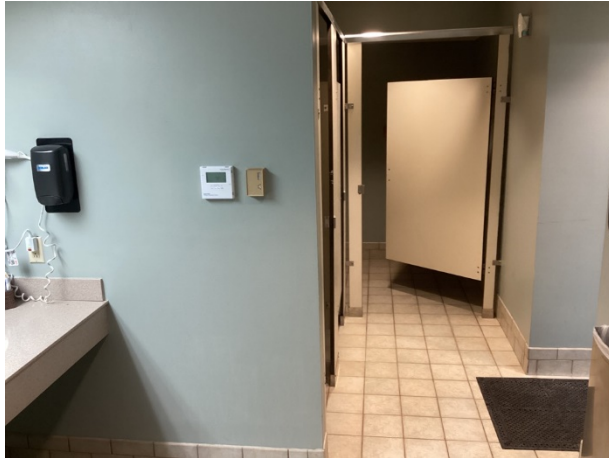
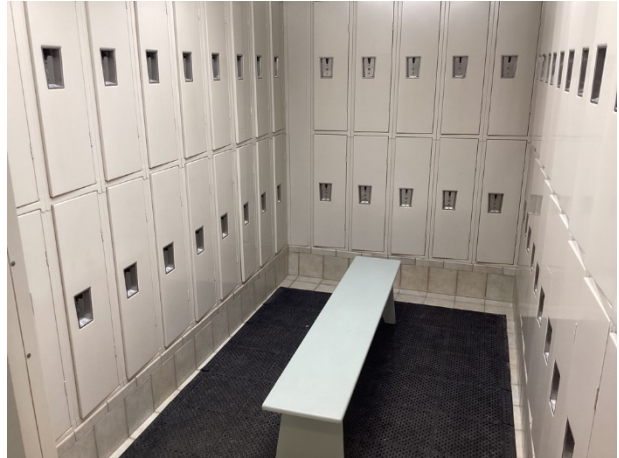
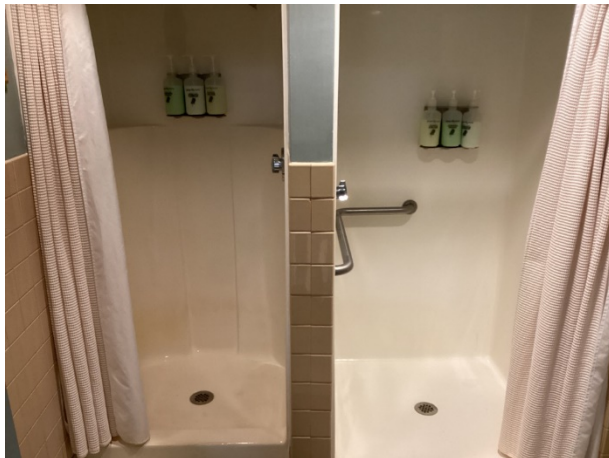
**Condition:** Fair overall with general deterioration evident

**Locker room overview**

**Metal lockers**

**Locker room showers**

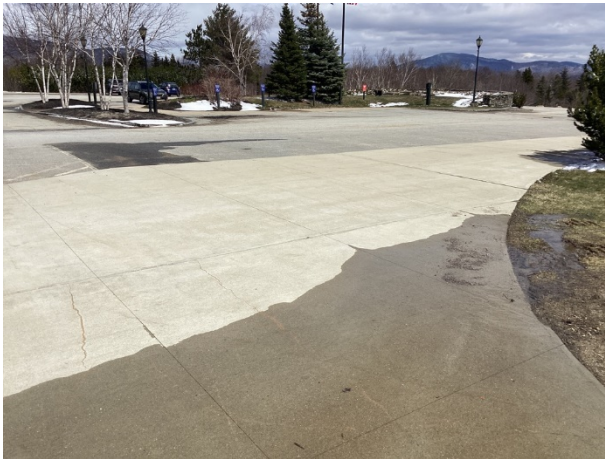
Sidewalk overview

**Condition:** Fair overall with cracks and spalls evident

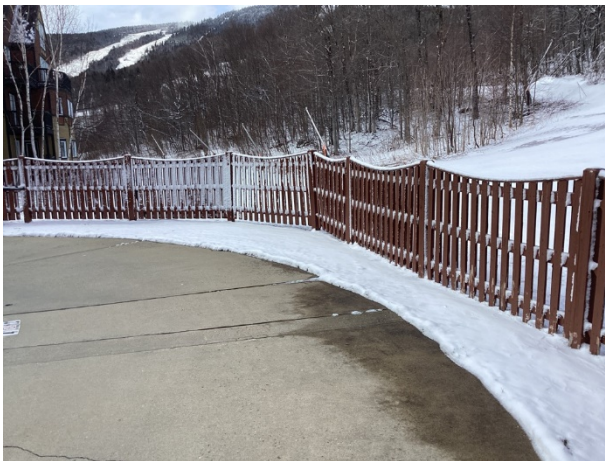
**Condition:** Reported unsatisfactory

Fence overview

**History:** Original; Will be replaced in 2022 with a vinyl fence.

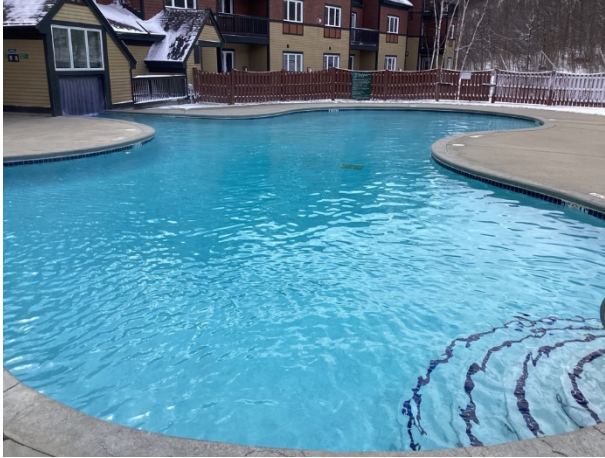
**Pool plaster overview**

**Condition:** Good to fair overall

- Removal and replacement of the plaster finish
- Partial replacements of the scuppers and coping as needed
- Replacement of tiles as needed
- Replacement of joint sealants as needed
- Concrete structure repairs as needed

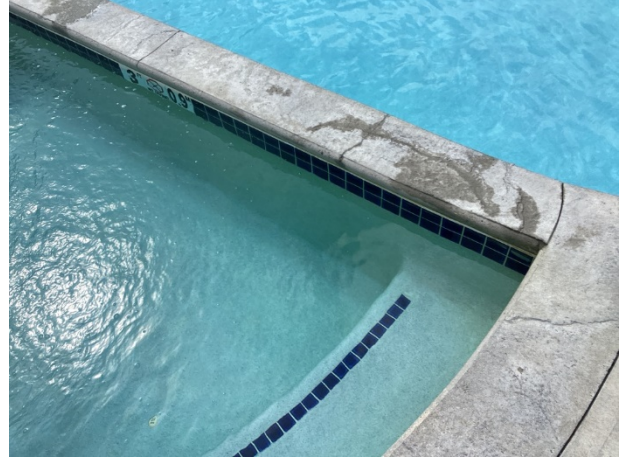
**Pool plaster finish with tile perimeter**
